# Manhole Inspection Summary

Manhole # S15II\_012MH

Insp Date: **2/20/09 9:58 AM**

**Location** Address: **1646 THOMAS AVE**

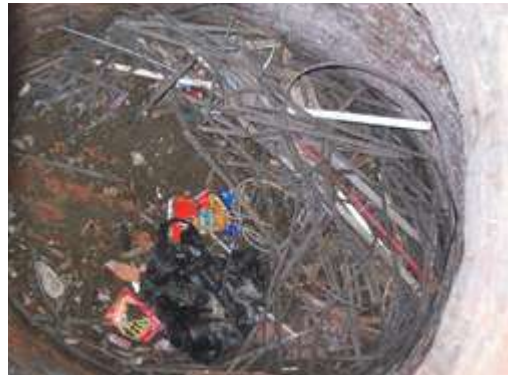
Top View

DEBRIS

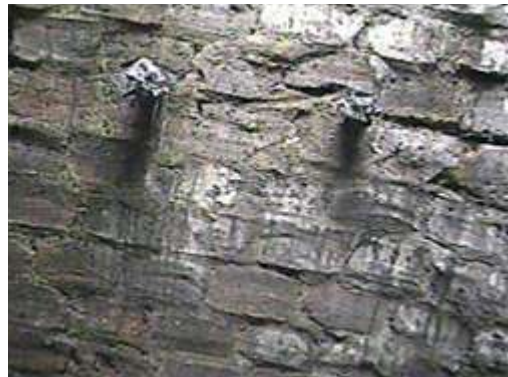
Defect 1

Count: **2** Missing: **1** ☒ **Corroded**

MISSING CORRODED RUNG

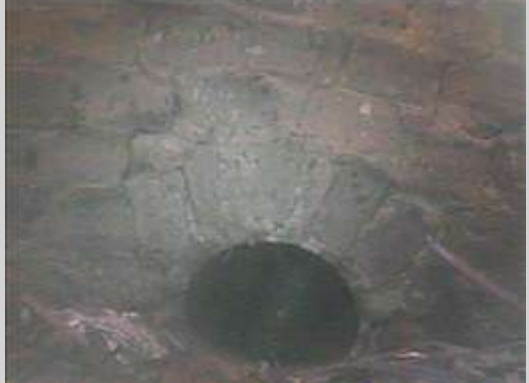
12 O'Clock Outflow

8 in. Circular Gravity Sewer  
Pipe Out @ 12 O'Clock

Deposits: ☐ None ☐ Mud ☐ Sludge ☒ **Debris** ☐ Grease

Silt Depth: **6** (in.) Deposits Extent: **Heavy**
